Title of Action: Life Skills vs. Nationwide Insurance Company

• Determine the cause of the reported vertical displacement of the floor structure at the northwest corner of the ceramics room and to determine if the reported damage was considered a collapse.

Insured: Life Skills, Inc. Claim No.: 494880-GK

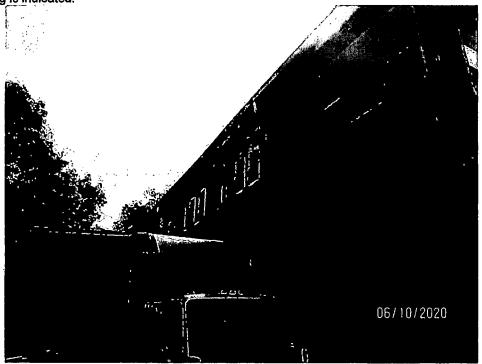
Photo No. 2: View of the north elevation of the building.

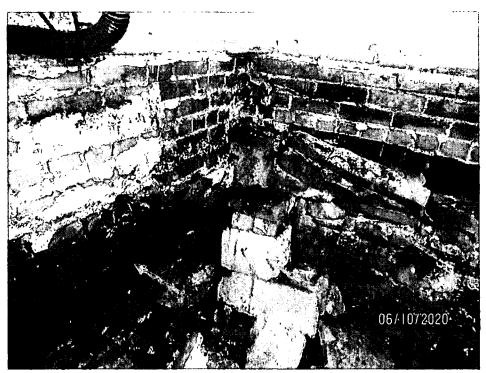
- The timber beams were sistered with wood beams that were notched to mitigate historical vertical displacement resulting from the decayed timber beams.
- Stacked CMU was observed under the westernmost beam adjacent to the west foundation wall.
- Bricks at the interior face off the north foundation wall were detached from the foundation wall and laying on the ground.
- The mortar at the northwest corner of the foundation was powdery.
- The westernmost ledger beam was detached from the wall and laying on the ground.

Photo No. 5: Closer view of the northwest corner of the foundation. Note the stacked CMU, powdery mortar, and decayed wood.
